APOLLO 15
30-DAY FAILURE AND ANOMALY LISTING REPORT

MANNED SPACECRAFT CENTER
HOUSTON, TEXAS
SEPTEMBER 1971

1.0 INTRODUCTION

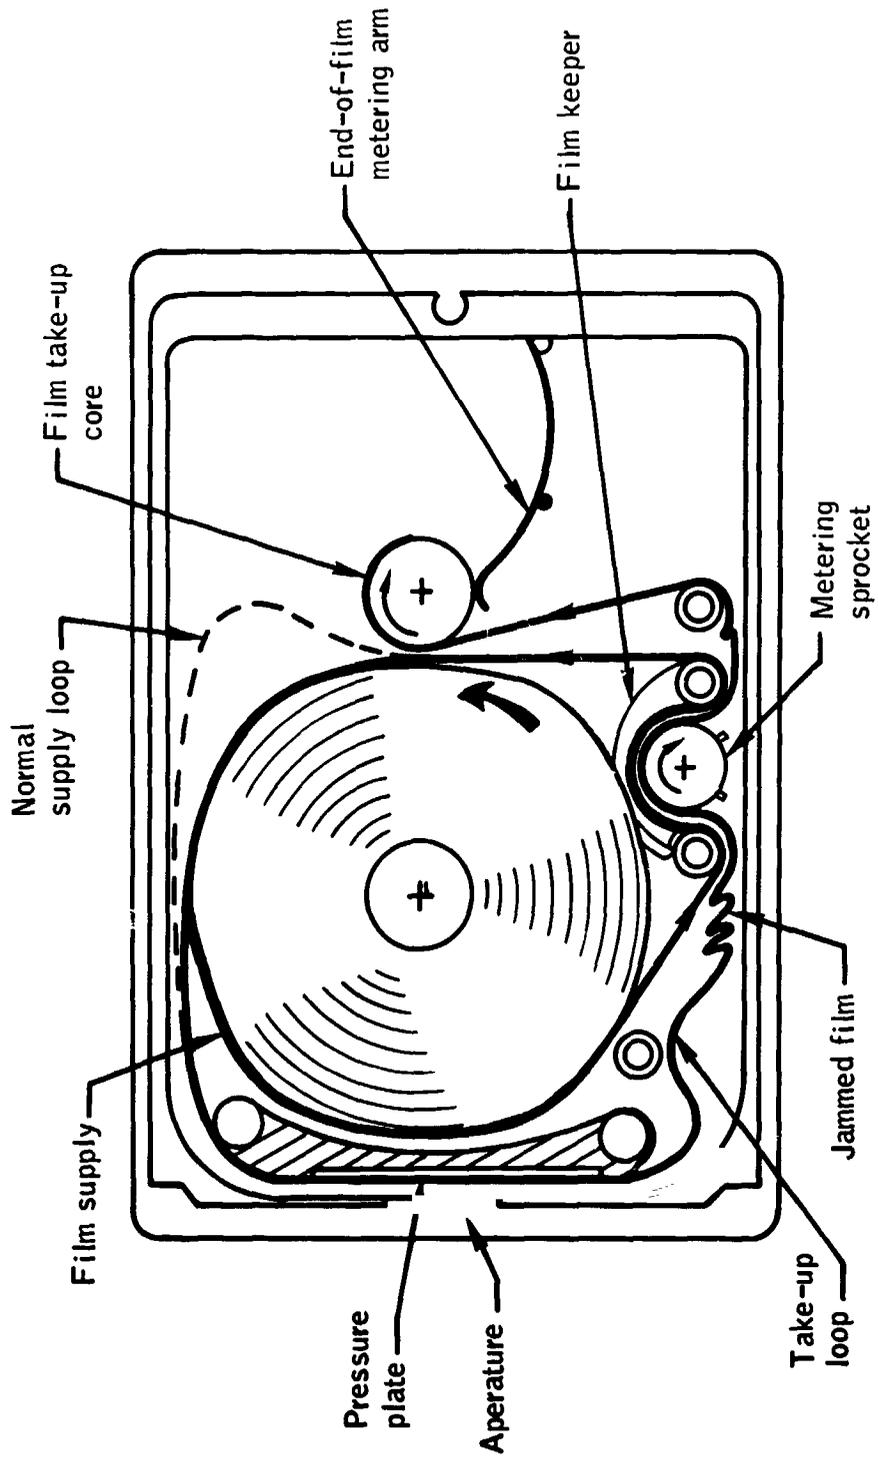
Figure 6-4.- Lunar surface 16mm camera magazine .

a. The first magazine installed showed, by damage to the magazine drive spline and scratches on the front face, that installation in the camera was improper and the magazine and camera were misaligned. Misalignment of the floating female spline of the camera with the male spline of the magazine was such that metal was removed from the brass male spline. The magazine spline shaft is attached to the metering sprocket (fig. 6-4). Mismatching results in depleting the film supply loop without allowing replenishment and takeup through the drive spline/metering sprocket mechanism. The lower, or takeup, loop becomes accordion folded, thereby jamming in the metering sprocket gate (fig 6-4). Two other magazines exhibited damaged drive splines, indicating that mismatching occurred on at least three occasions. Pictures taken of the lunar roving vehicle with photographs taken with the lunar surface 70-mm camera show that a strip of tape installed on the 16-mm camera magazine for latch stowage protection was not removed prior to installation of a film magazine. Leaving the tape strip in place does not allow the magazine latch to move down for normal magazine installation. Although the crew reported no problem with magazine installation in this condition, this could have contributed to the camera/magazine mismatching.

b. In the course of troubleshooting, the crew manually advanced the film in all remaining magazines prior to the second extravehicular activity and again prior to the third extravehicular activity. The amount of manual advancement varied from five to twenty-one frames in the several jammed magazines. The film supply loop (fig. 6-4) contains three to five frames excess. The normal procedure is to advance manually not more than one frame to verify perforation indexing. The excessive advancement depleted the film supply loops in all magazines, creating again the excessive takeup loop condition causing accordion folding and jamming in the metering sprocket (fig. 6-4).

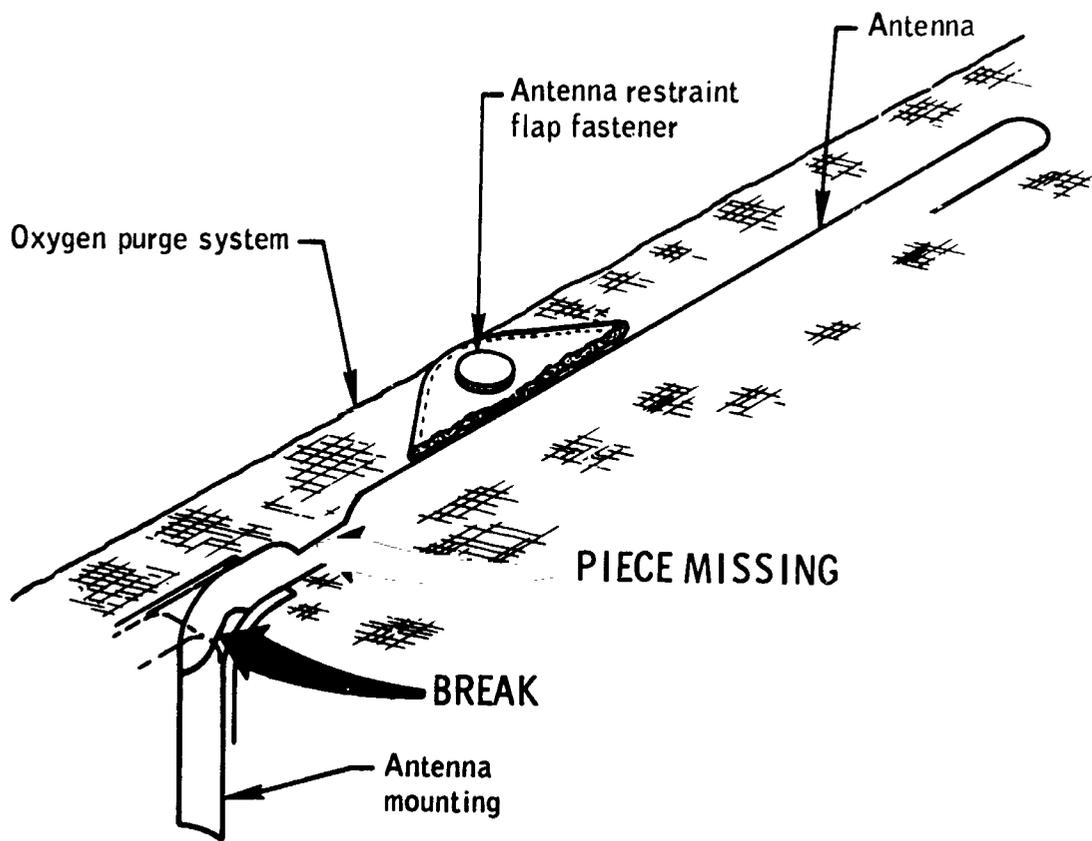
Figure 6-5.- Damaged antenna stowed on oxygen purge system.

Antennas broken in training have shown similar flexure breaks. Preliminary observation of the notch edges indicates the notch started as a partial break in flexure, followed by material removal by being torn out the rest of the way.

The material in the returned antenna is being tested for physical properties including brittleness which could account for easy breaking. Possible changes in deployment and stowage of the antenna are under consideration.
